**MANDATORY BULLETIN No. EV 97 – 007 a  
SPORTSTAR – 002 a**

#### 4.5.1.5 Oil Filter Replacement

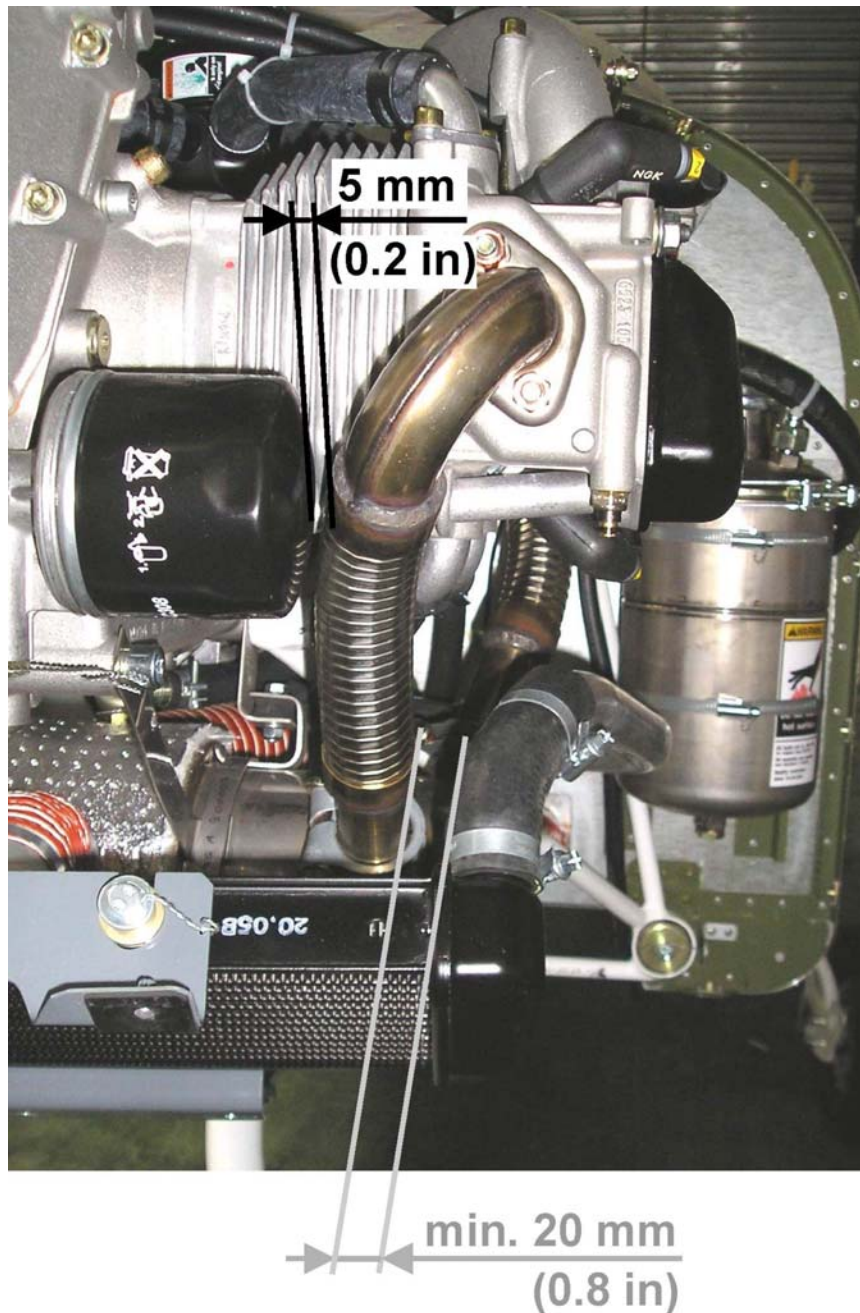
1. **CONCERNING TO :** Insufficient clearance between a left rubber hose of engine radiator and front left cylinder exhaust manifold.
2. **REASON :** Engine radiator left rubber hose burn-out caused by a waveguide of the front left cylinder exhaust manifold occurred in service. The cause was an insufficient clearance between the hose and the exhaust manifold waveguide. Insufficient clearance was caused during replacement of oil filter, when the exhaust manifold of front left cylinder should be loosen and turned slightly to allow removal of the oil filter. Minimum safe clearance of 20mm (4/5“) between the exhaust manifold and radiator left rubber hose must be ensured when the exhaust manifold re-installed.

3. **REQUIRED ACTION :** It must be ensured during every replacement of the oil filter, that after re-installation of the front left cylinder exhaust manifold the minimum safe clearance of 20mm (4/5“) from the engine radiator rubber hose and 5mm (1/5“) from the oil filter is kept; see Enclosure of this Bulletin. A visual inspection for undesirable interaction between the cooling system hoses and exhaust manifold to be performed during pre-flight inspections. Damaged hoses to be replaced prior to the nearest flight. Clearance between the cooling system hoses and exhaust manifold to be checked during periodical inspections.

Remove engine cowlings. Unscrew the elbow on the left front (as viewed in flight direction) exhaust pipe using nut wrench size 12. Loose a clamp of that pip on the exhaust muffler using wrench 13. Disconnect the elbow from the engine and turn the exhaust pipe slightly to move it from the oil filter. Replace oil filter by a new one. See Maintenance Manual (Line Maintenance) for ROTAX Engine Type 912 Series for replacement instructions. Connect the elbow to the engine and tighten the nuts slightly by fingers. Set exhaust pipe clearance from the radiator hose and oil filter. Clearance from the radiator hose must be min. 0.8 in (20 mm) and approximately 0.2 in (5 mm) from oil filter. When clearances are set, tighten the elbow and clamp. Re-install the engine cowlings after oil re-filling.
