MANDATORY BULLETIN No. SPORTSTAR – 005 a

1. **CONCERNING TO :** All SportStar airplanes.
Visual inspection of attachment of the hand control slide bearing brackets
2. **REASON :** There were found 3 missing rivets on the airplane S/N 20050414 operated in the Australia, after 950 hours flown. These rivets attach the upper flange of the hand control slide bearing bracket to the wing-center section main spar upper flange. This was shown itself with a slightly reduced stiffness and effectiveness of the hand control. Direct jeopardy of flight safety was not reported .

Appendix 1 Procedure to inspect attachment of the hand control slide bearing brackets

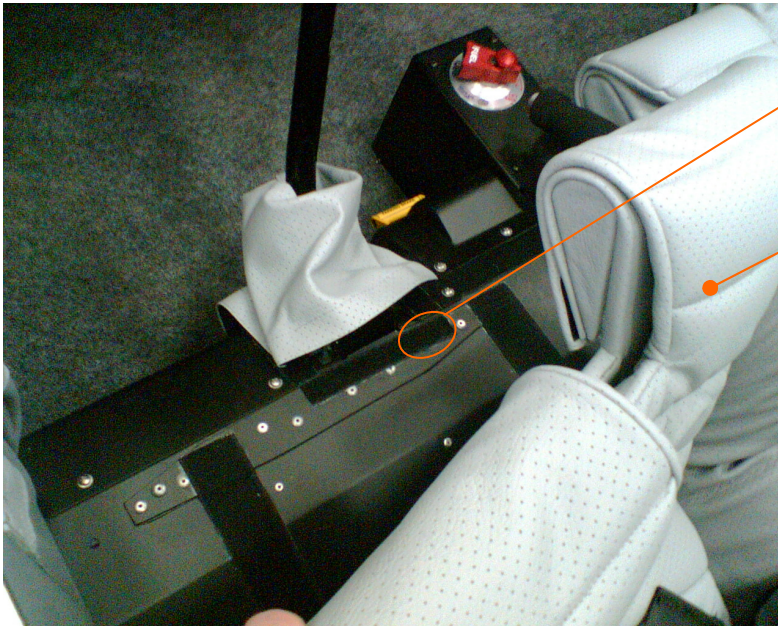
Visual inspection area
In the same way perform
inspection under right seat

Left seat upholstery

2. If the 3 highlighted rivets are riveted then the inspection is completed.
3. Record fulfilment with the bulletin into the Airplane Log Book.
4. If the 3 highlighted rivets are missing on any of sides, then contact the airplane producer immediately through your local dealer for further instructions. A more thorough inspection of the hand control attachment will be necessary with adding of missing rivets.

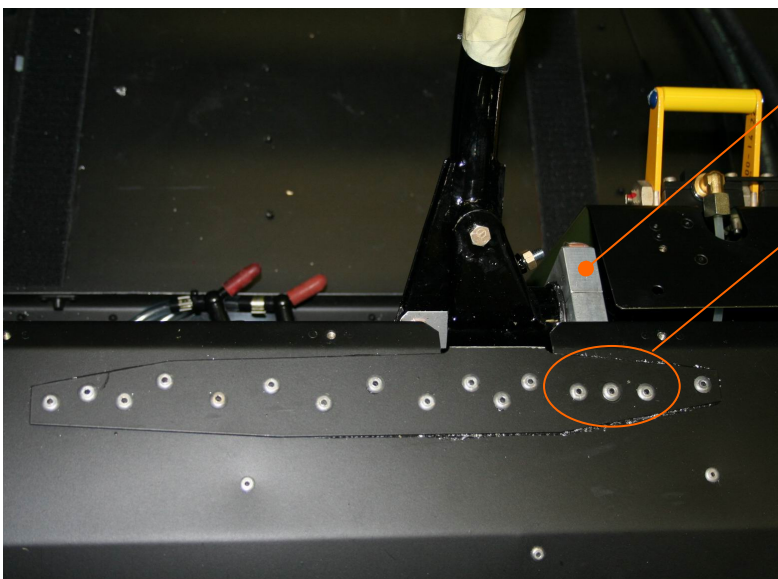
Left duralumin slide bearing
of the hand control

3 rivets attaching upper
flange of the left slide
bearing bracket to the
upper flange of the wing-
center section main spar.

Inspect attachment under
right seat, as well !

5. The stiffness thus effectiveness of the hand control might be reduced in case of missing rivets. The airplane manufacturer therefore does not recommend to fly the airplane until more thorough inspection of the hand control attachment being carried out and missing rivets added.
